SITE INVESTIGATIONS
FOR RESIDENTIAL DEVELOPMENT
ON THE PORT HILLS,
CHRISTCHURCH

A thesis
submitted in partial fulfilment
of the requirements for the Degree
of
Master of Science in Engineering Geology
in the
University of Canterbury
by
Barry J. McDowell

University of Canterbury
1989

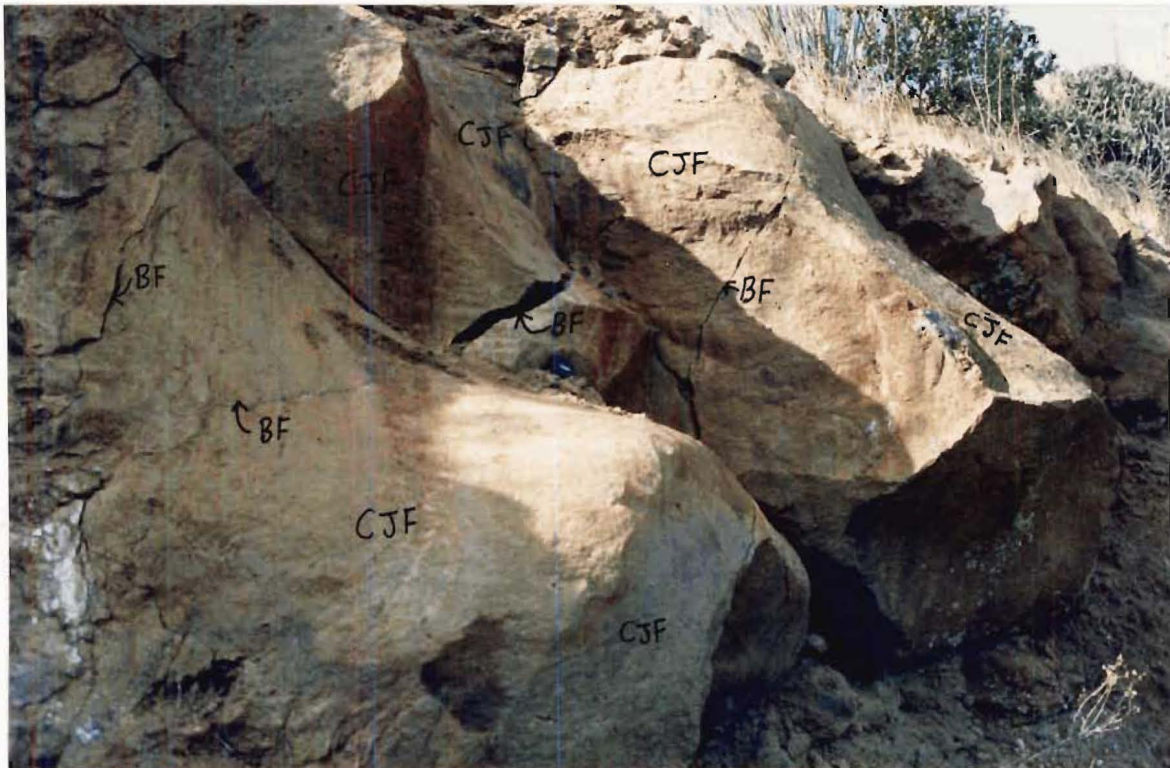
Figure 2.4 : Massive Lava on Lot 24 showing well developed cooling joints and blast fractures. CJF= cooling joint face
BF= blast fracture

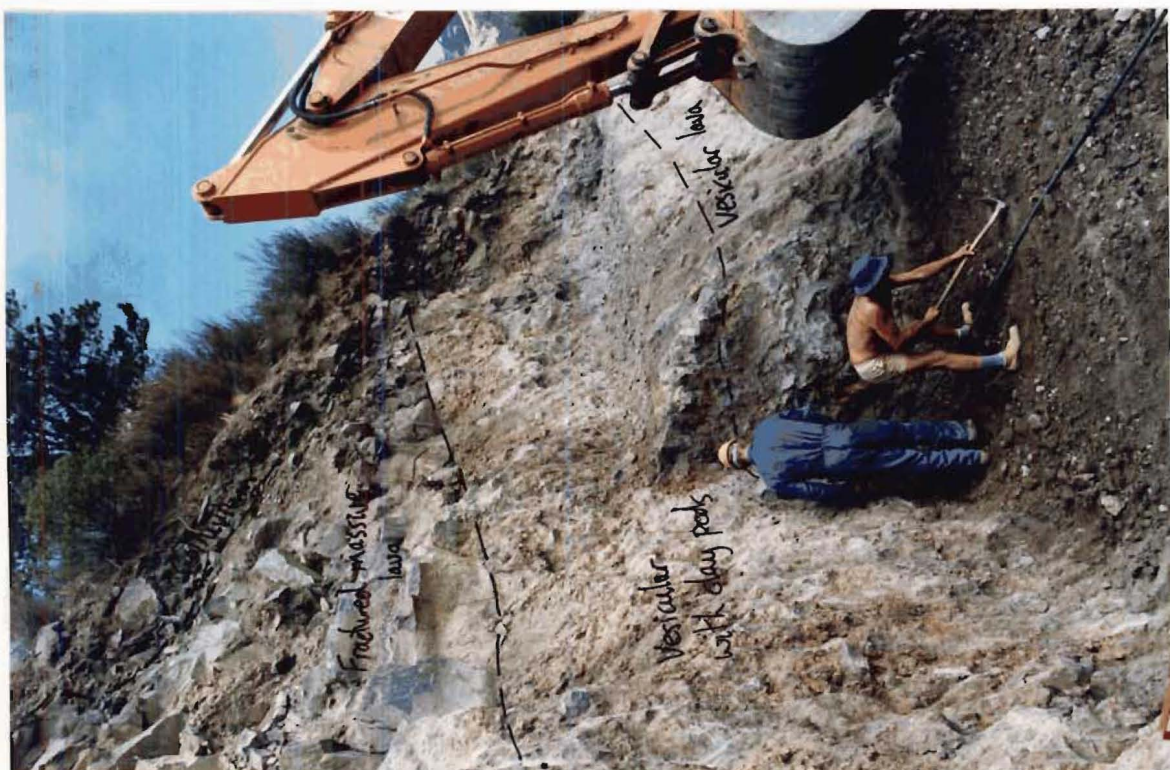
Figure 2.5 : Bench Preparation for Gabion Wall. Vesicular lava, vesic. with clay pods, blast fractured massive lava and colluvial material are indicated

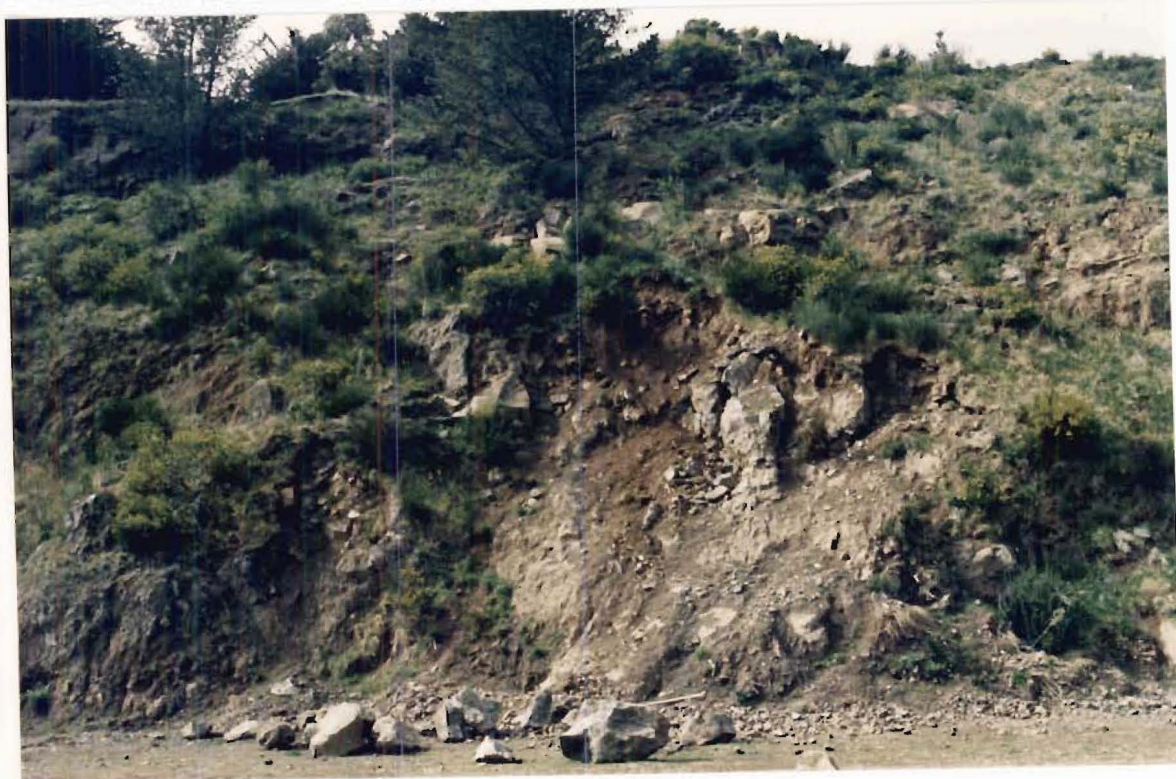
Figure 2.13 : Fresh Natural Failure in Loose Colluvium and Blast Damaged Bedrock (photo taken October, 1986)

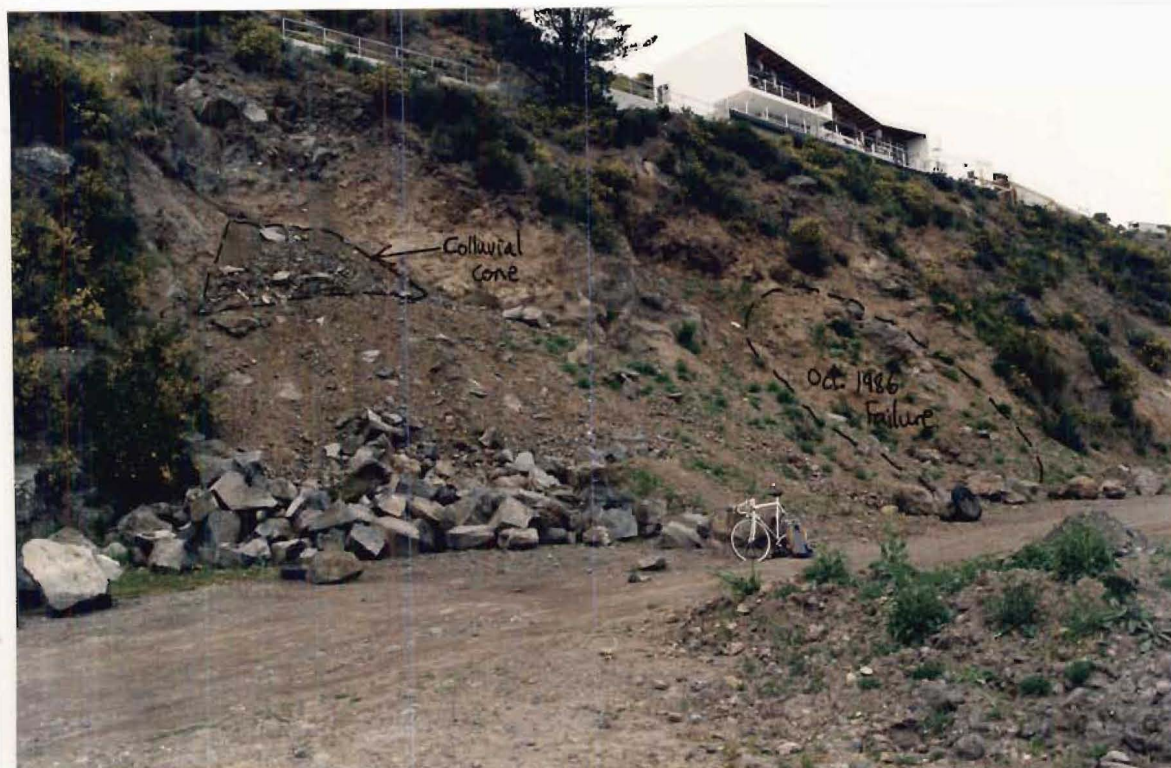
Figure 2.14 : Limit of Fretting after Backhoe Excavations and Before Building of Gabion Wall. Note colluvial cone (from fretting of scarp) on backhoe ramp, and site of October, 1986 failure (arrowed)

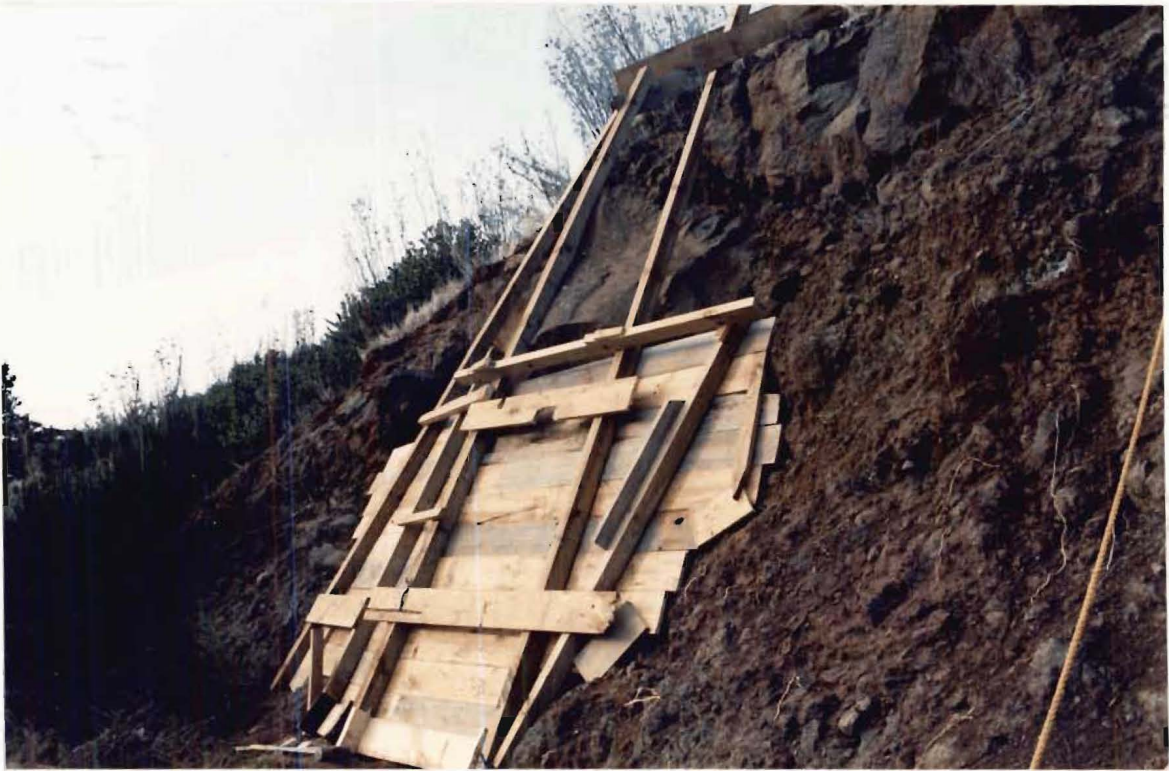
Figure 2.17 : Boxing in Place for Buttressing Massive Lava Blocks on Lot 24 Batter Slope

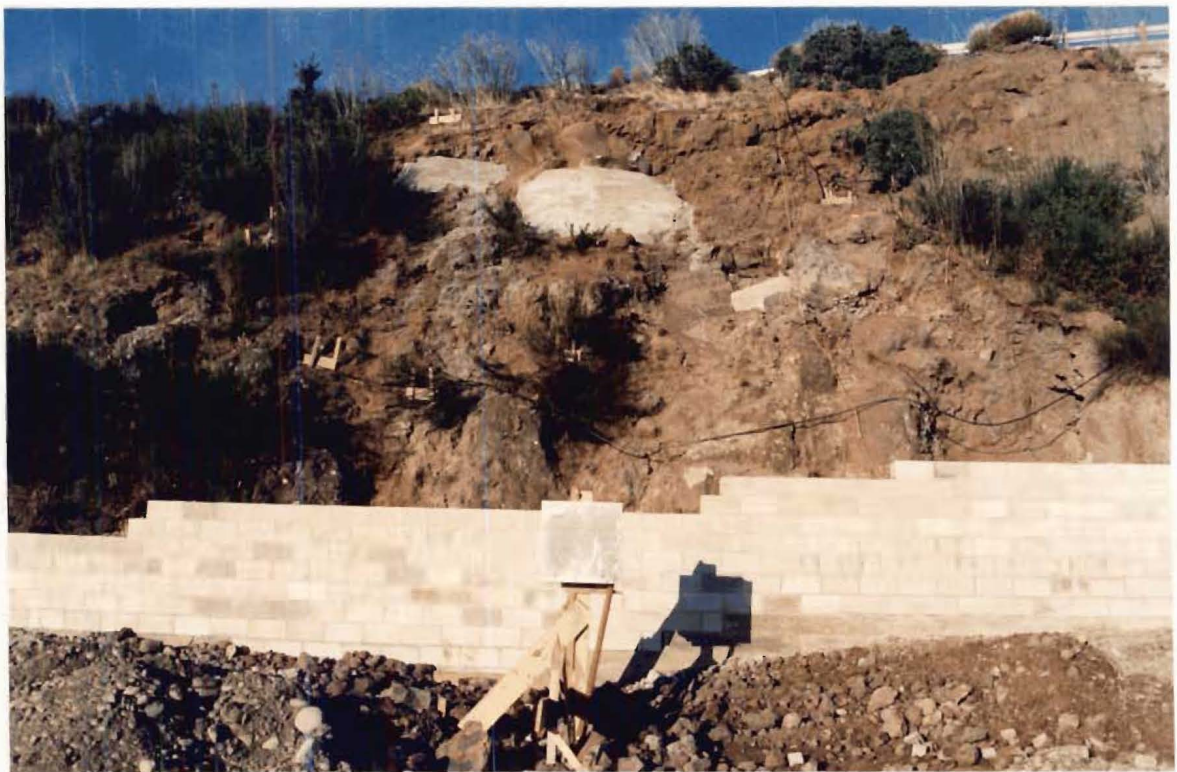
Figure 2.18 : Concrete Block Wall, Concrete Buttresses and Tree Planting Completed on Lot 24, South End

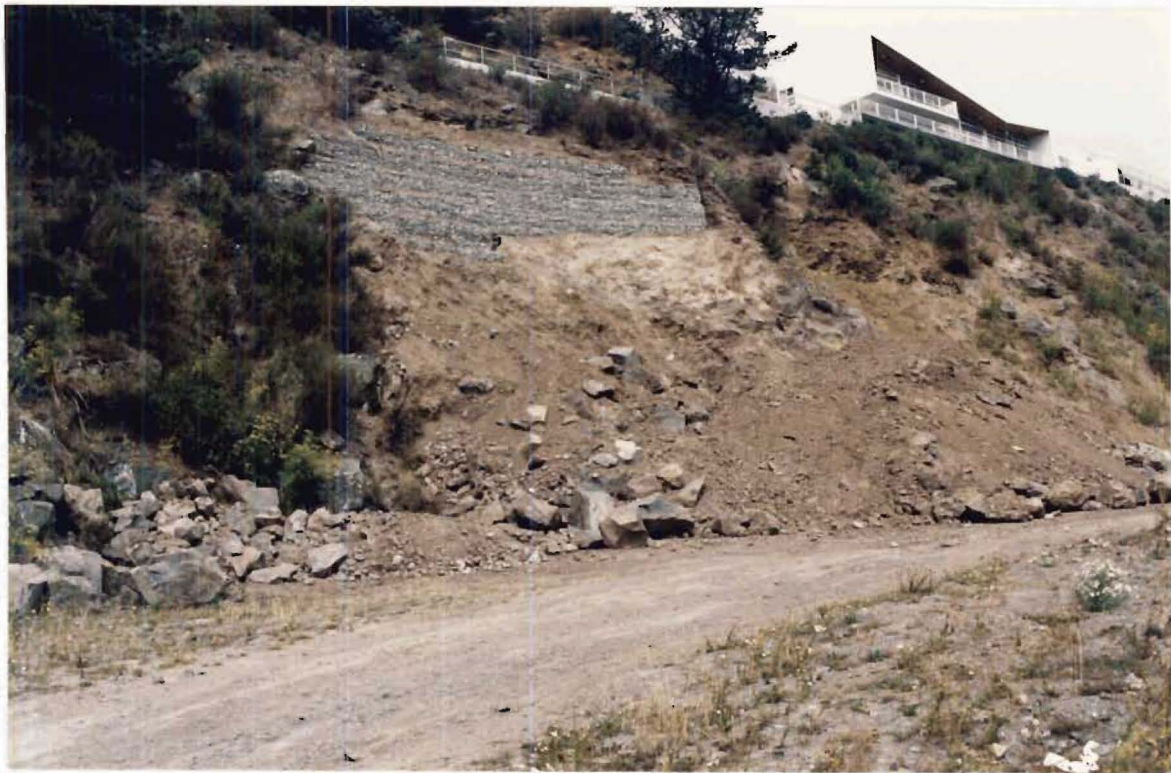
Figure 2.19 : Completed Gabion Wall. Wilson house and garden wall are on bench above

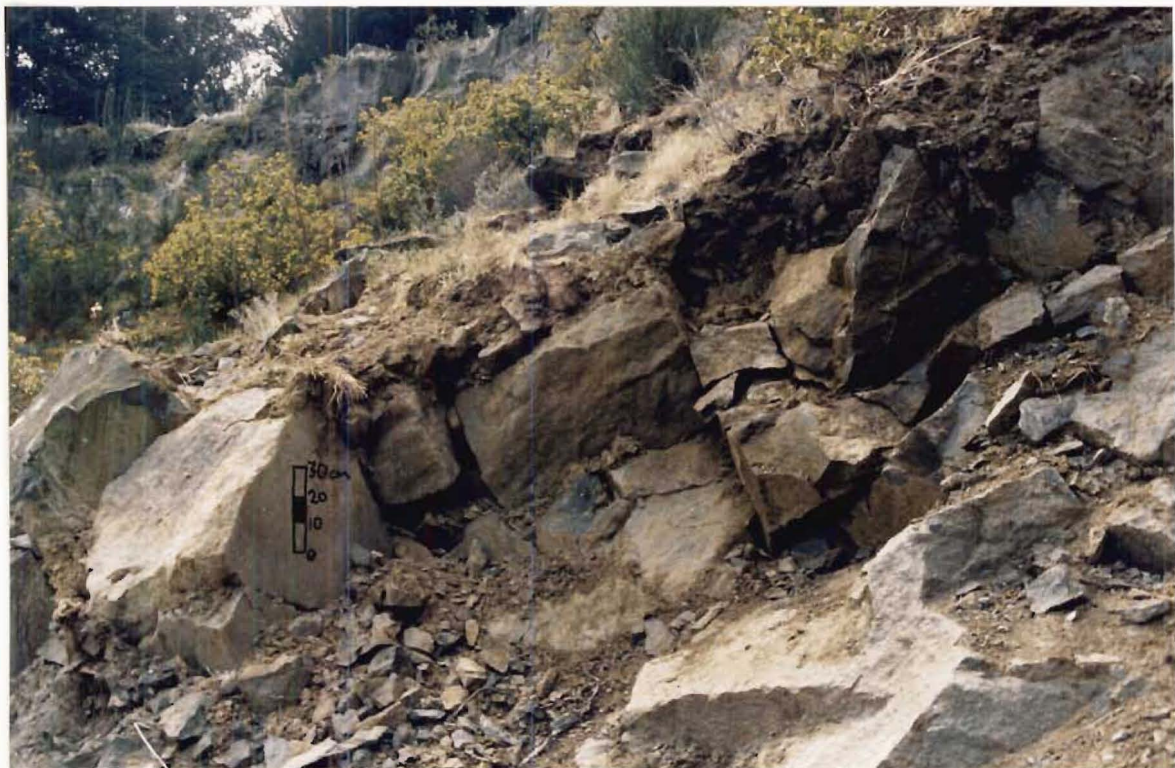
Figure 2.20 : Blast Fractured Massive Lava. Large blocks are bounded by opened cooling joints

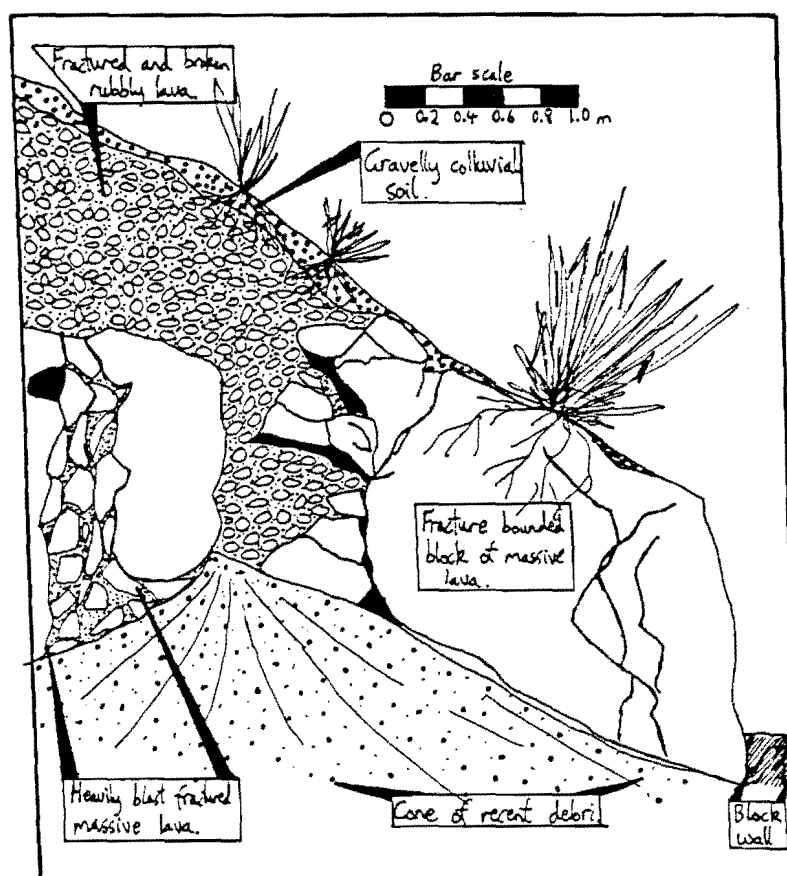
Figure 2.21 : Face Log at Base of Batter Slope, 5m South of Section B-B' (fig. 2.8). Massive block is buttressing fractured material

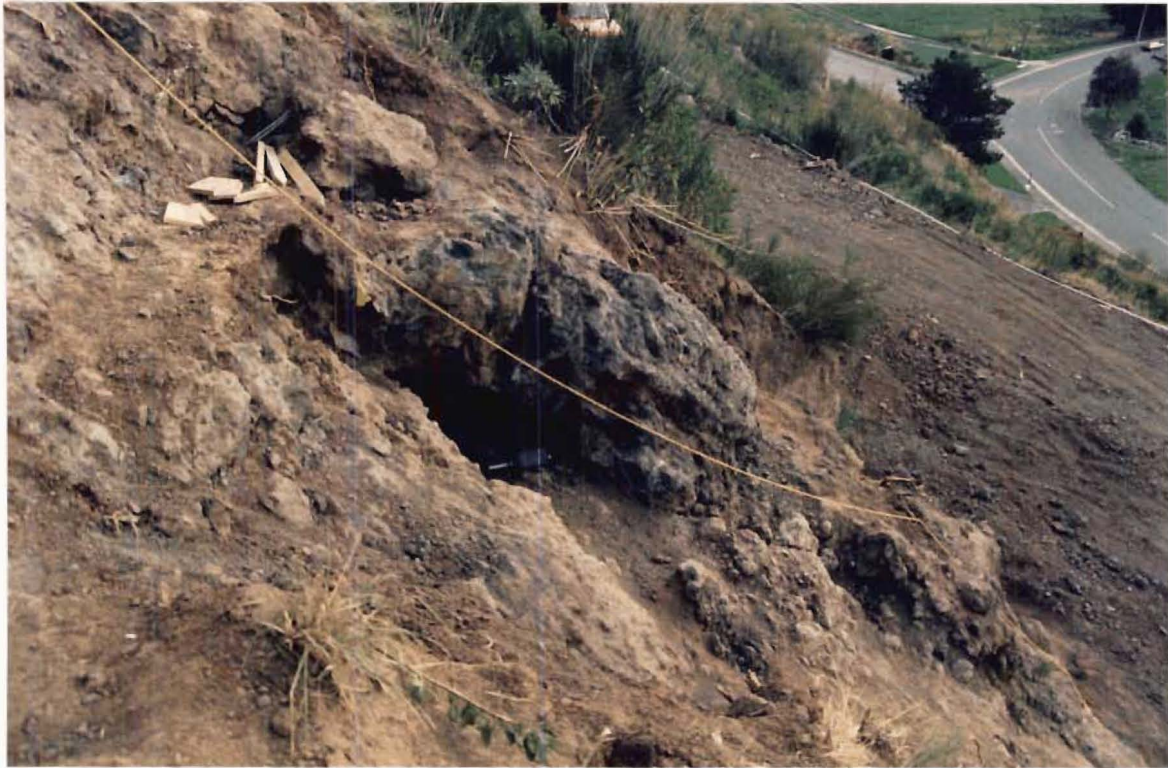
Figure 2.22 : Blast Crater in Vesicular Lava, Lot 24 Batter Slope.
Most of detached block has been trimmed by jackhammer

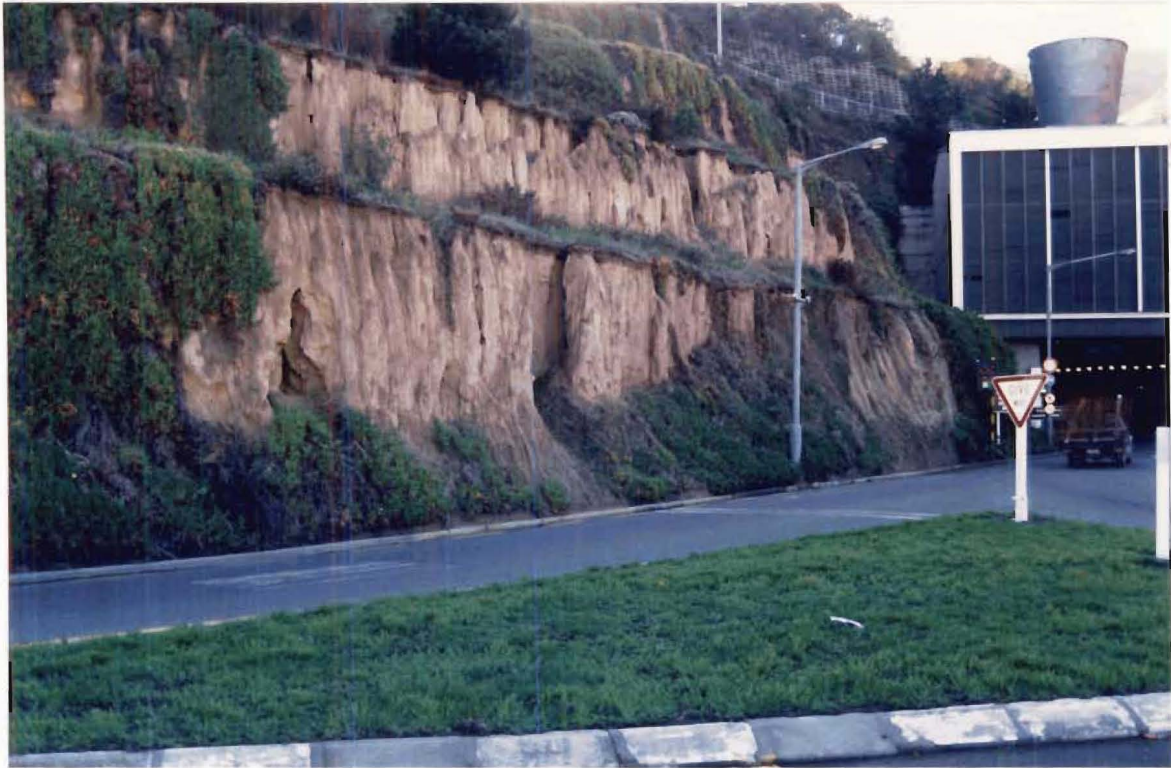
Figure 3.4 : Eroded loess bank Lyttelton tunnel entrance. Compare with Figure 3.2

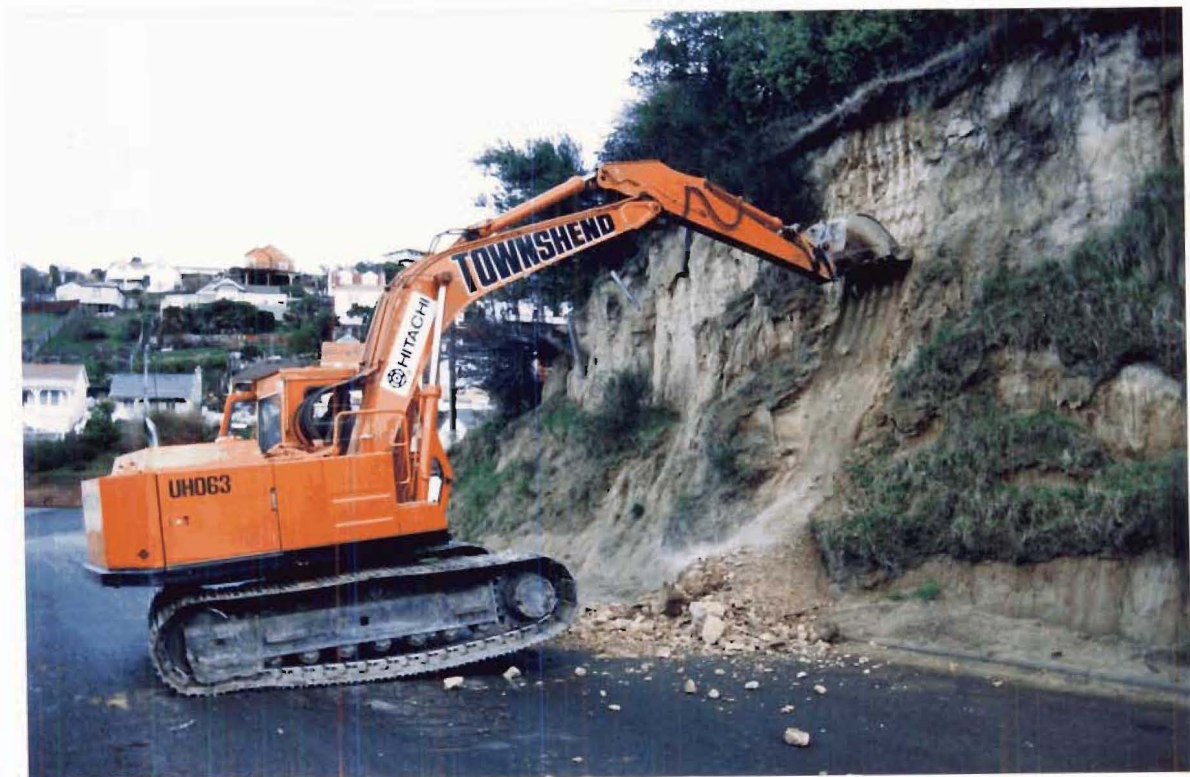
Figure 3.5 : Backhoe cutting sampling channel at West end of bank. Note loess is very hard and backhoe is tipping backwards, rather than cutting into bank

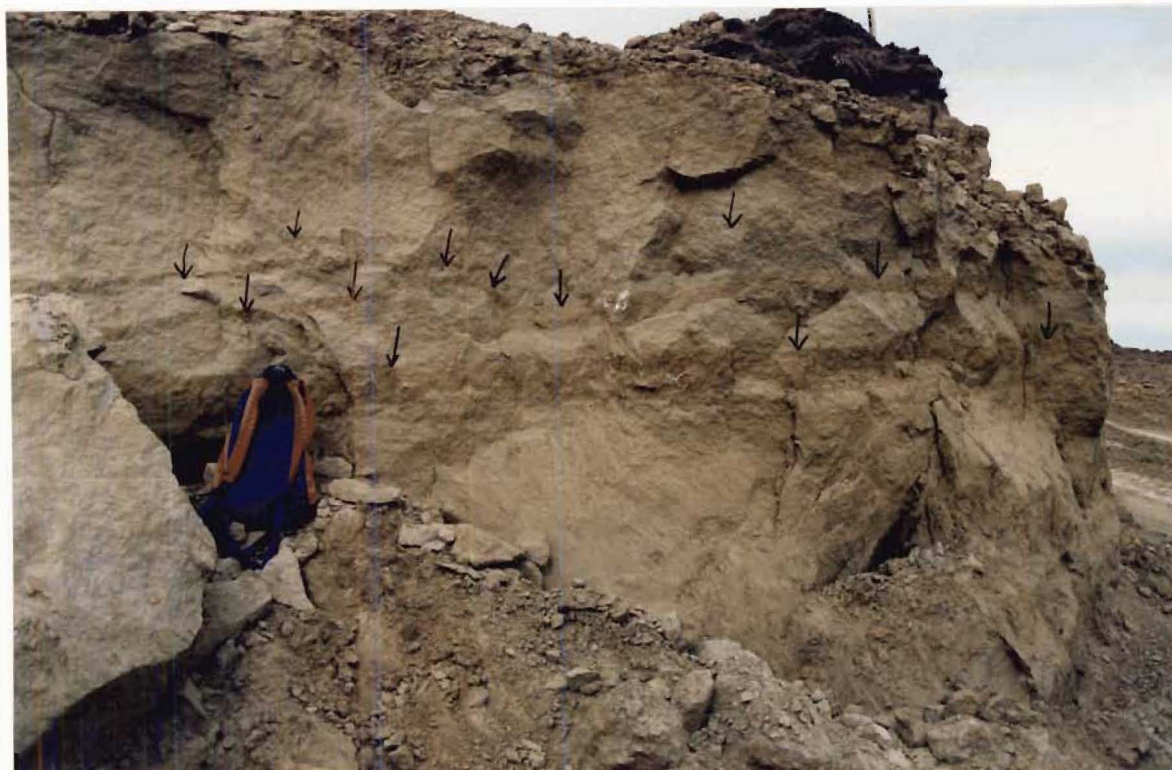
Figure 4.5 : Fresh Exposure in Cut Area D showing Multiple Buried Soil Horizons (arrowed) in Uppermost Loess. thin topsoil and mottled fragipan have been stripped from cut

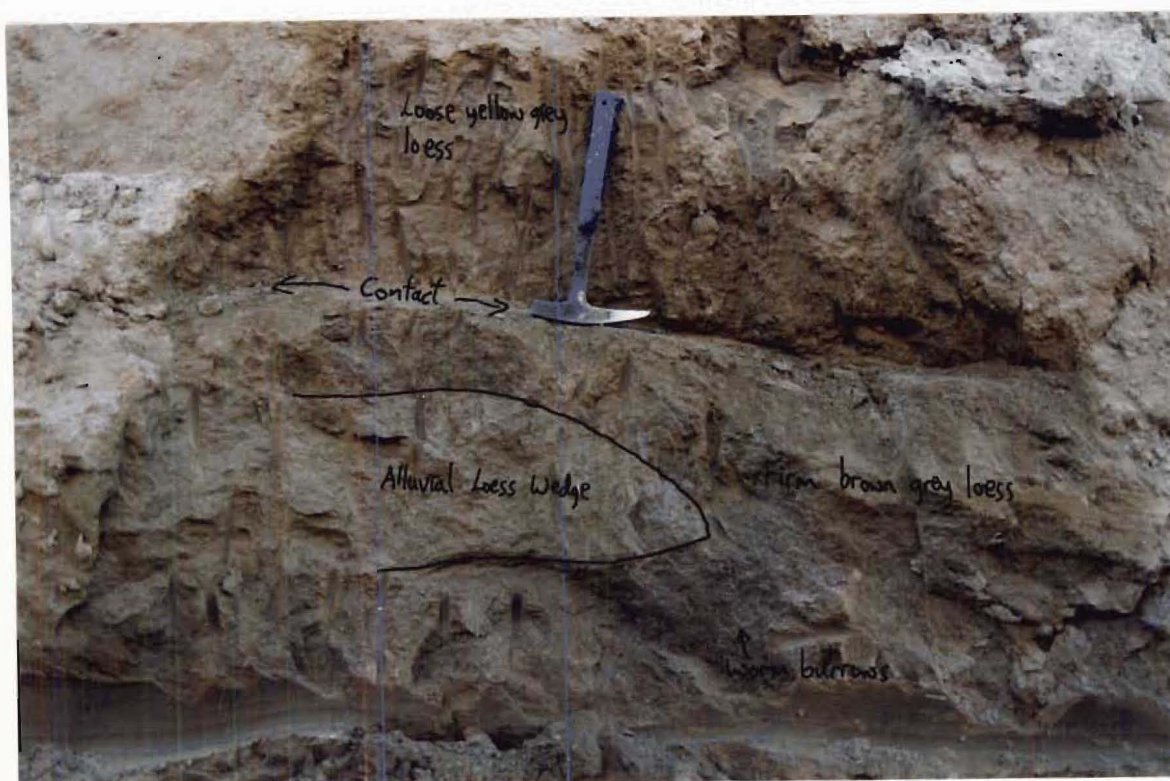
Figure 4.6 : Cut in South Flank of Gully showing Layering in Loess. Small alluvial wedge of sandy silt in relatively dense brown grey silt with worm burrows. Wavy, gently dipping contact with overlying loose massive yellow grey silt

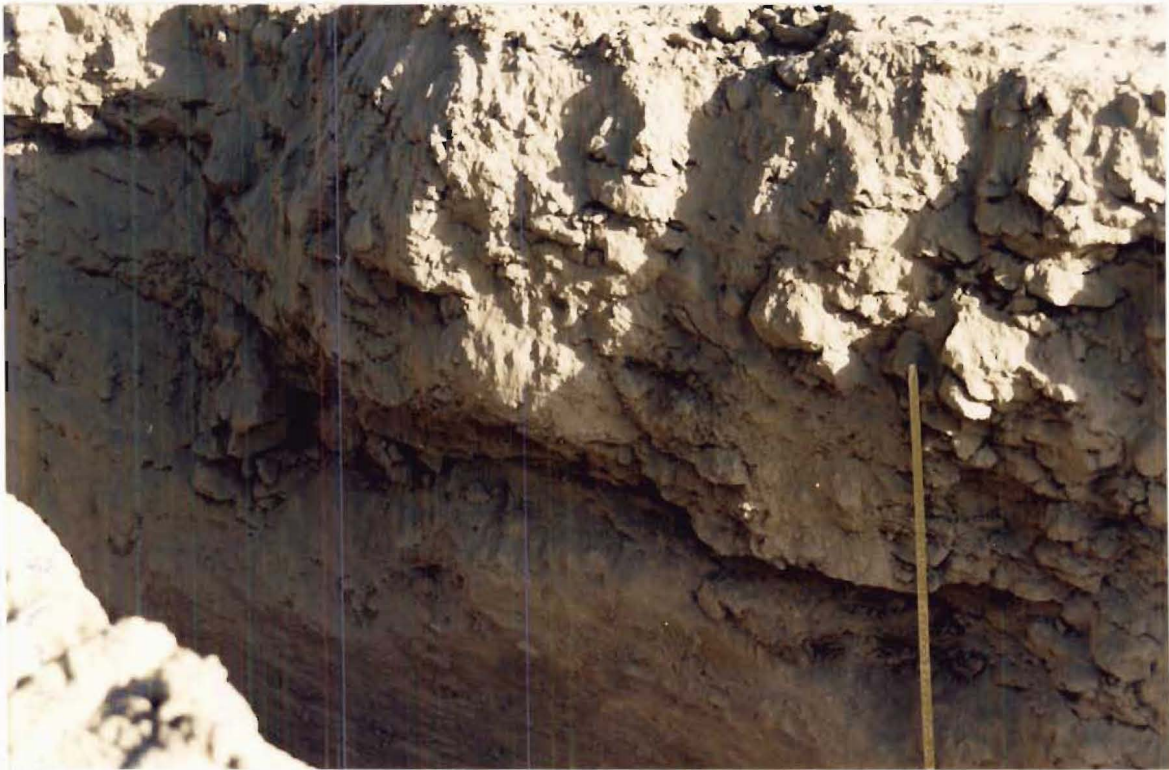
Figure 4.11 : Section of Trench Cut in Lower Half of Gully Fill. Shows moist massive fill overlain by blocky layered slightly moist fill. Partings between blocks are fracture discussed in fill stability and triaxial testing
